Our Reference: P-002185
20 October 2023

Ladies Mile Extension Preliminary Geotechnical Report For Plan Change Application

TE PŪTAHI LADIES MILE ZONE EXTENSION

GEOTECHNICAL INVESTIGATION LOCATION PLAN

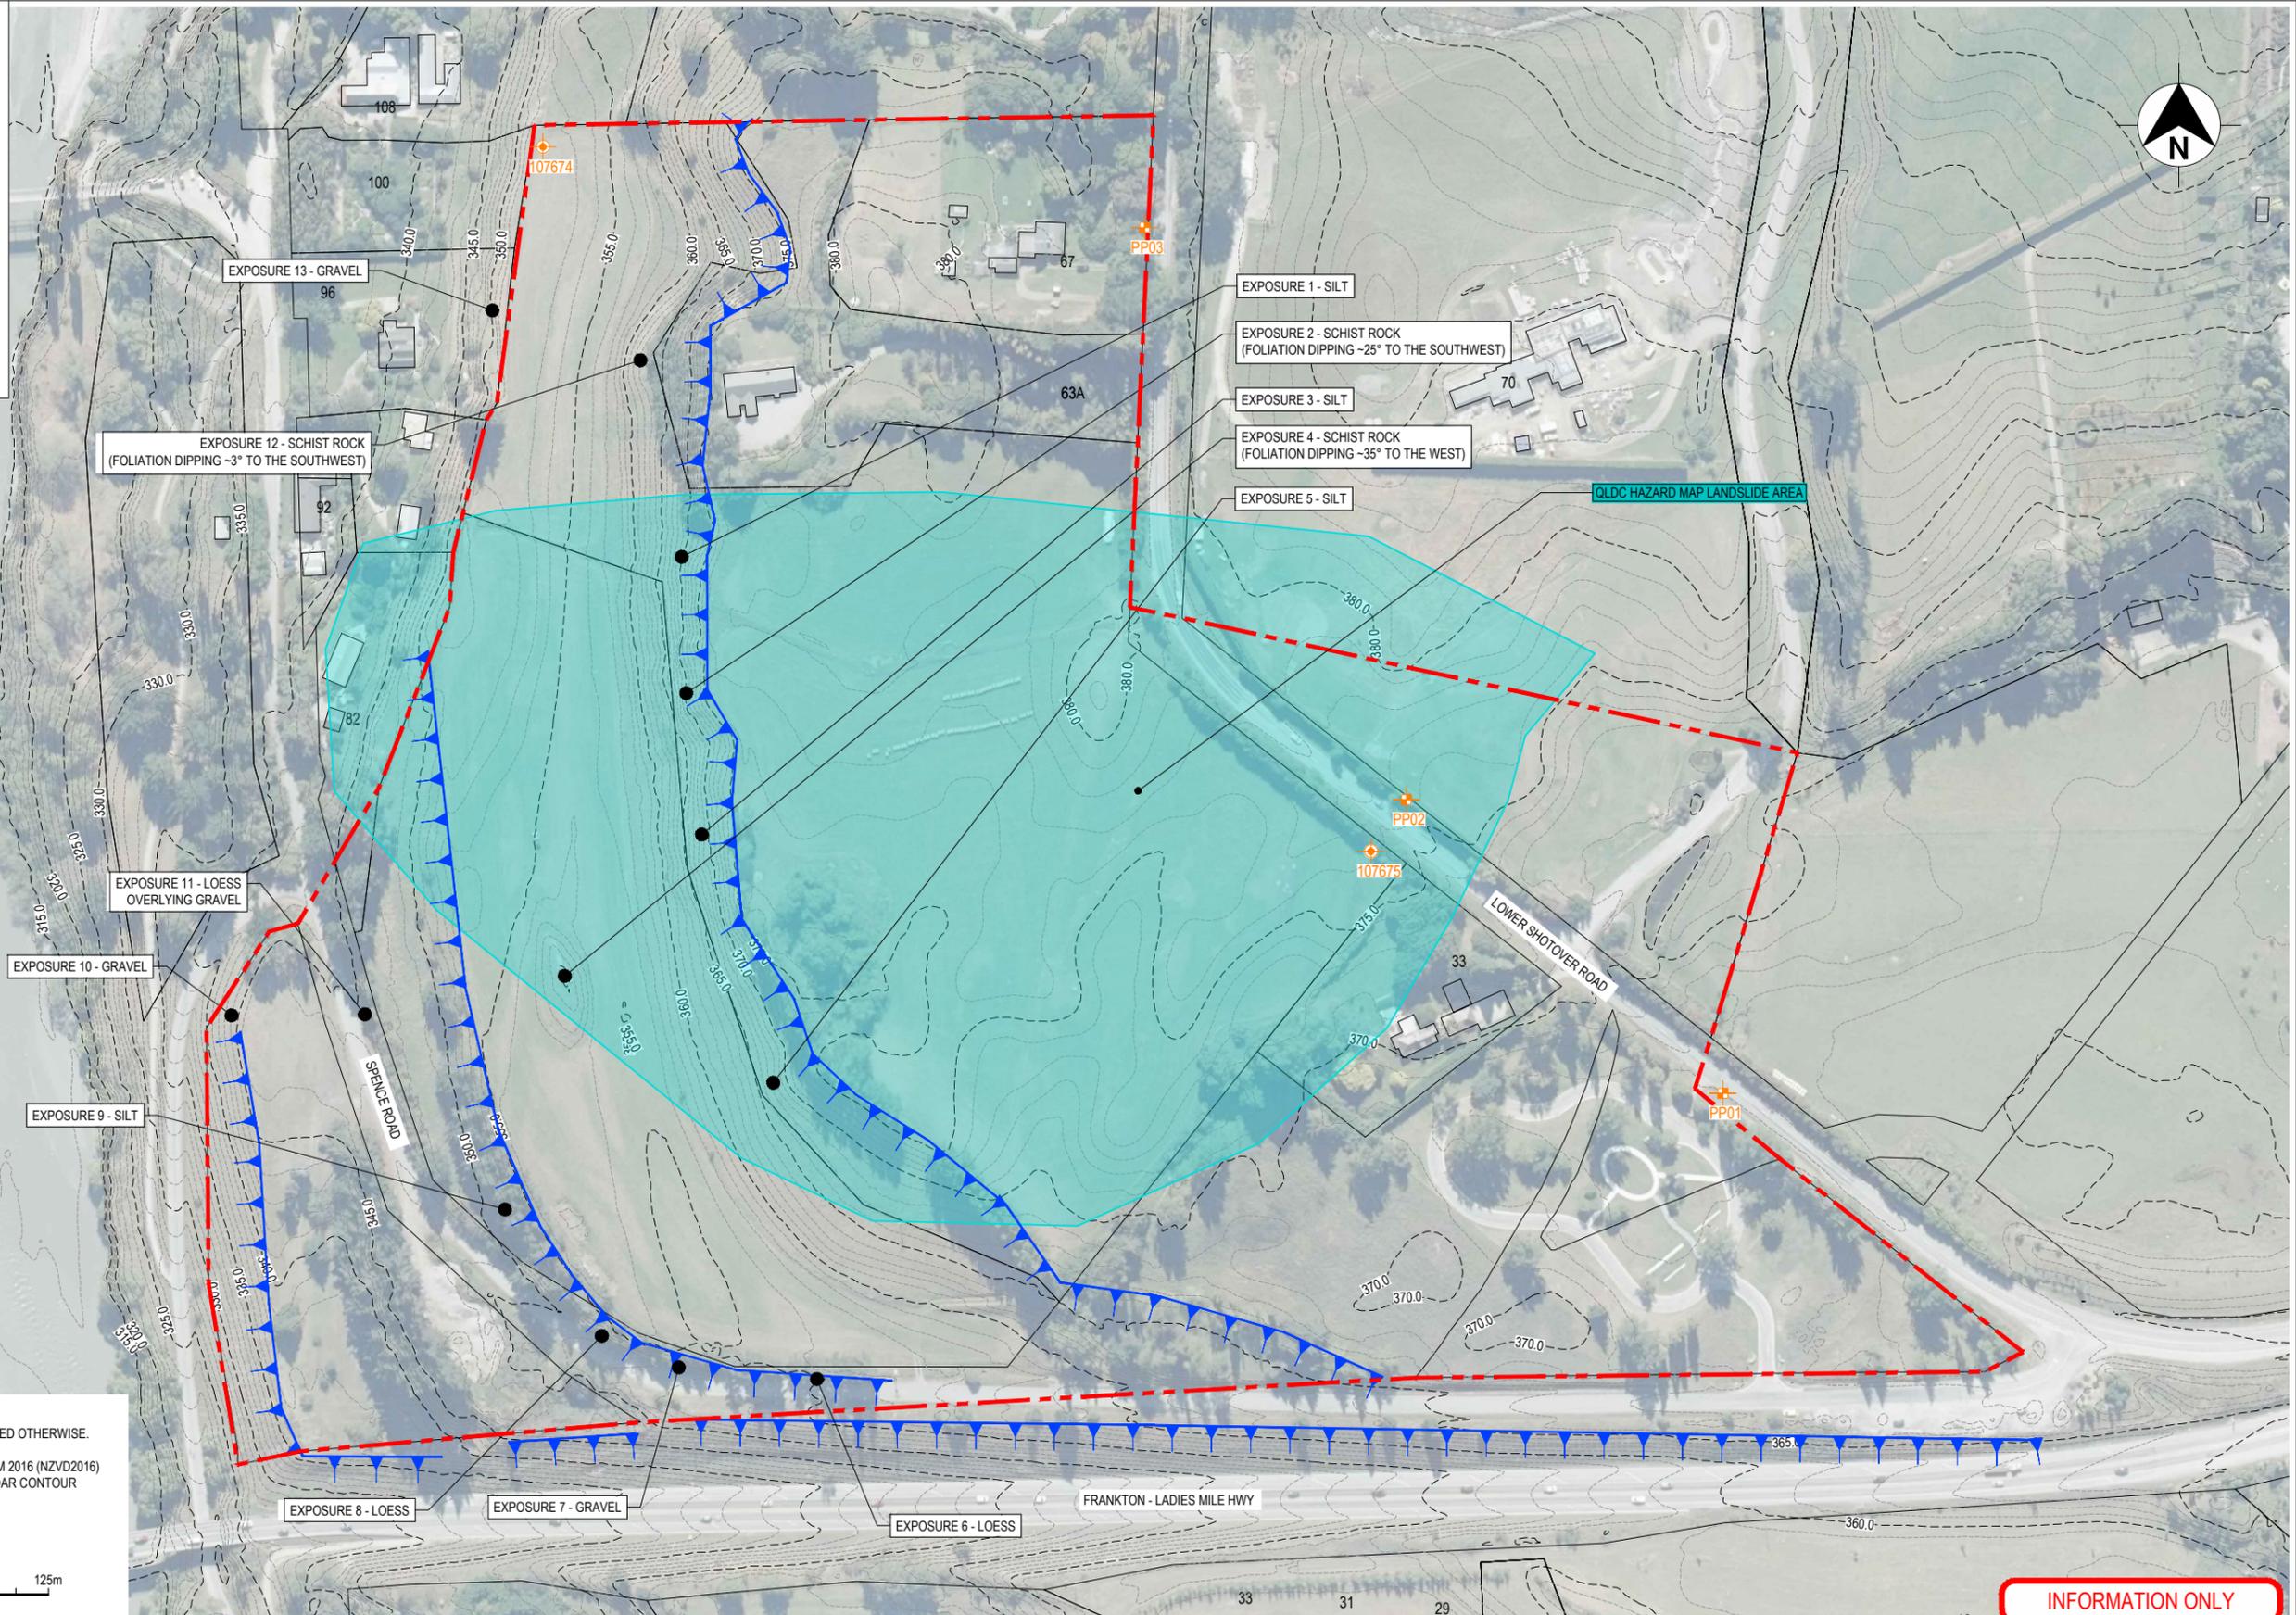
Initial Project ref:	P002185
Figure Number	2185-G01
Revision	A

The report also comments on the "Existing landslide feature" mapped on the QLDC hazard maps. The feature is presented in blue on Figure 2185-G01 attached in Appendix A. Geosolve conclude it is likely that the landslide feature shown on the QLDC hazard map is the result of an error during compilation.

A site walk over was carried out by an Initia Senior Engineering Geologist on 17 October 2023. No intrusive investigations were completed; however, inspection of local soil and rock exposures were carried out where available. The exposure locations with a brief description of the geological unit observed is presented on Figure 2185-G01 attached in Appendix A.

We note that the above units are typical of materials encountered in landforms dominated by fluvial processes. These materials are not associated with landslide features. The locations where each of the above units were observed in outcrop is presented on Figure 2185-G01 attached in Appendix A.

No evidence of global stability issues were identified. In particular we concur with the conclusion of Geosolve that the mapped instability feature on the QLDC hazard map does not appear to be related to any actual feature on site and may have been a compilation error. The site is considered to be geotechnically suitable for residential development, noting additional geotechnical investigations and analysis will be required at the subdivision design and resource consent stage. Detailed slope stability analysis should be carried out on proposed building platforms near the crest or toe of any river terrace riser or other significant slope.
