**SHOTOVER PROPERTY
INVESTMENTS LTD**

Frankton Flats Development

Geotechnical Investigations

December 2010

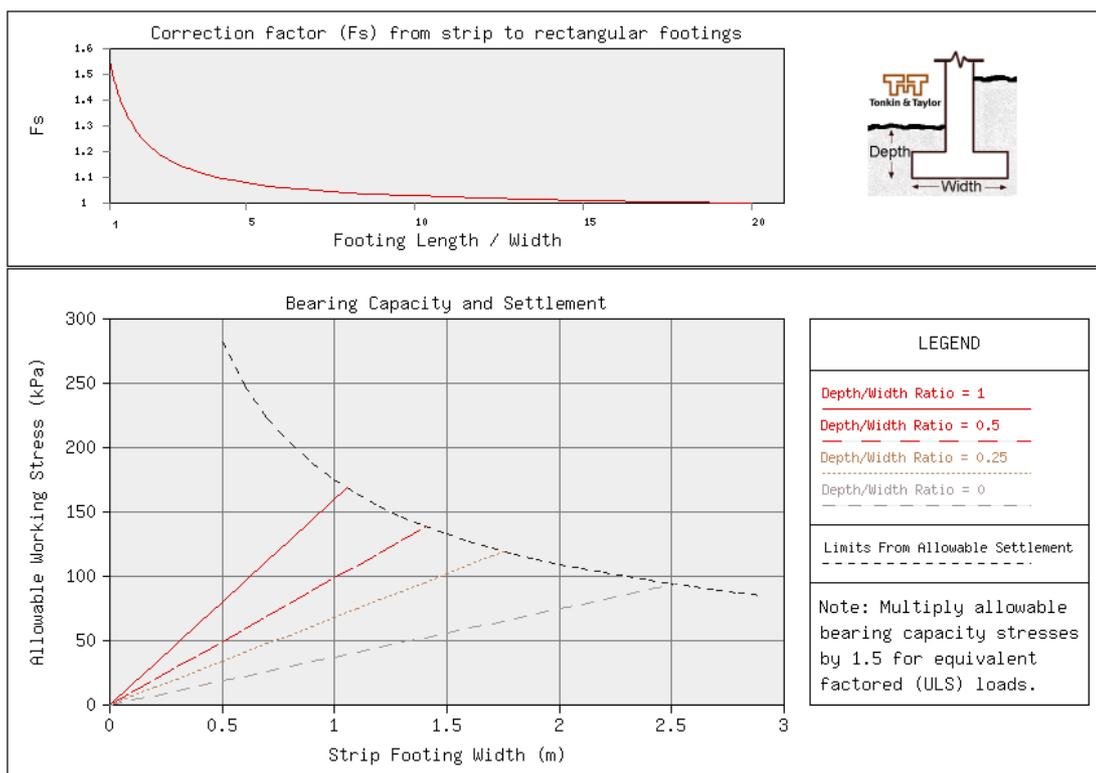
Figure 5-1. Recommended Bearing Pressures for Footings

Conservative site-specific bearing for shallow footings is recommended in Figure 5-1, but higher bearing may be possible after inspection of excavations and testing of the foundation subgrade areas. Footing stresses are limited by differential settlement where foundations straddle the different materials.

No reduction for earthquake loading is applicable.

Foundations for the structures will be predominantly on lake sediments including silt and sand. Enhanced bearing could be obtained by founding on the deltaic gravel or fill compacted in accordance with NZS 4431.

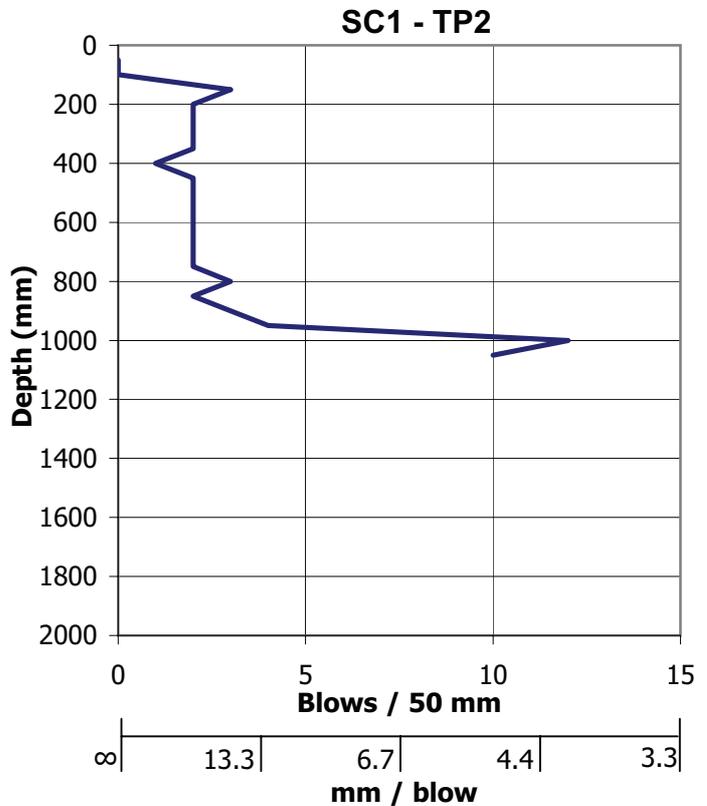
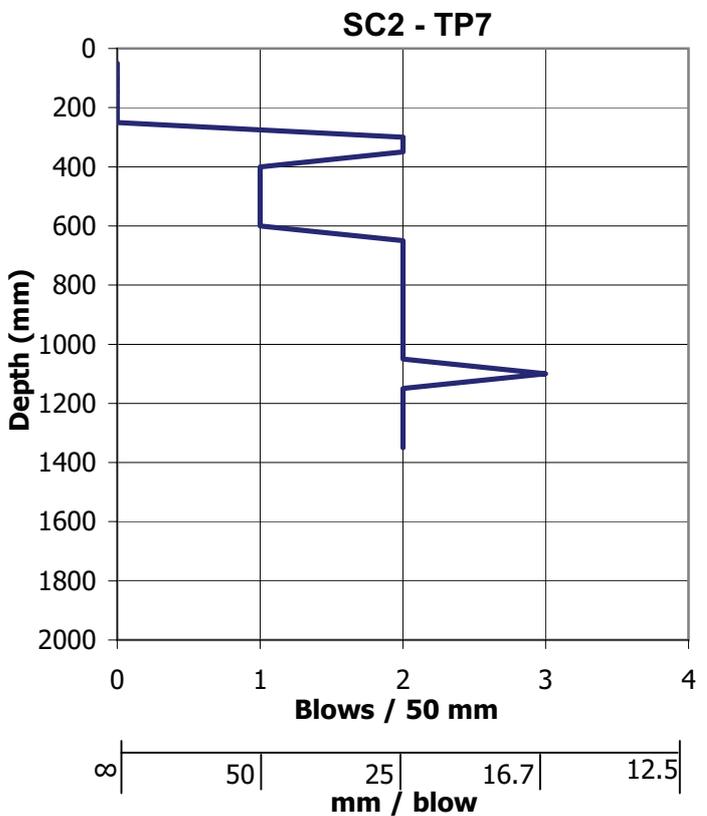
TONKIN & TAYLOR
SCALA PENETROMETER LOG

SC1 - TP2	
Location: RL: 0m	
mm Driven	No. of Blows
50	
100	
150	3
200	2
250	2
300	2
350	2
400	1
450	2
500	2
550	2
600	2
650	2
700	2
750	2
800	3
850	2
900	3
950	4
1000	12
1050	10
1100	
1150	
1200	
1250	
1300	
1350	
1400	
1450	
1500	
1550	
1600	
1650	
1700	
1750	
1800	
1850	
1900	
1950	
2000

SC2 - TP7	
Location: RL: 0m	
mm Driven	No. of Blows
50	
100	
150	
200	
250	
300	2
350	2
400	1
450	1
500	1
550	1
600	1
650	2
700	2
750	2
800	2
850	2
900	2
950	2
1000	2
1050	2
1100	3
1150	2
1200	2
1250	2
1300	2
1350	2
1400	
1450	
1500	
1550	
1600	
1650	
1700	
1750	
1800	
1850	
1900	
1950	
2000

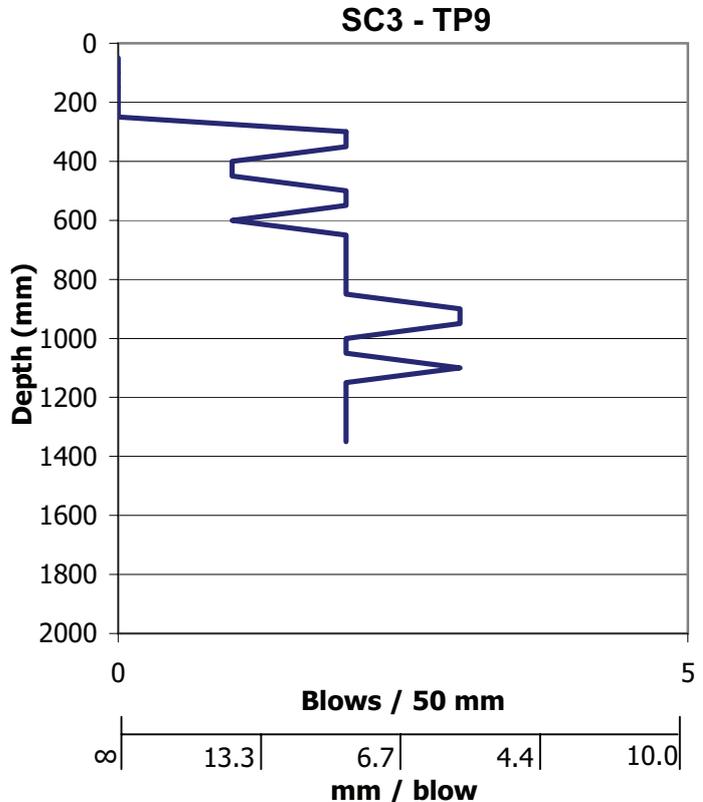
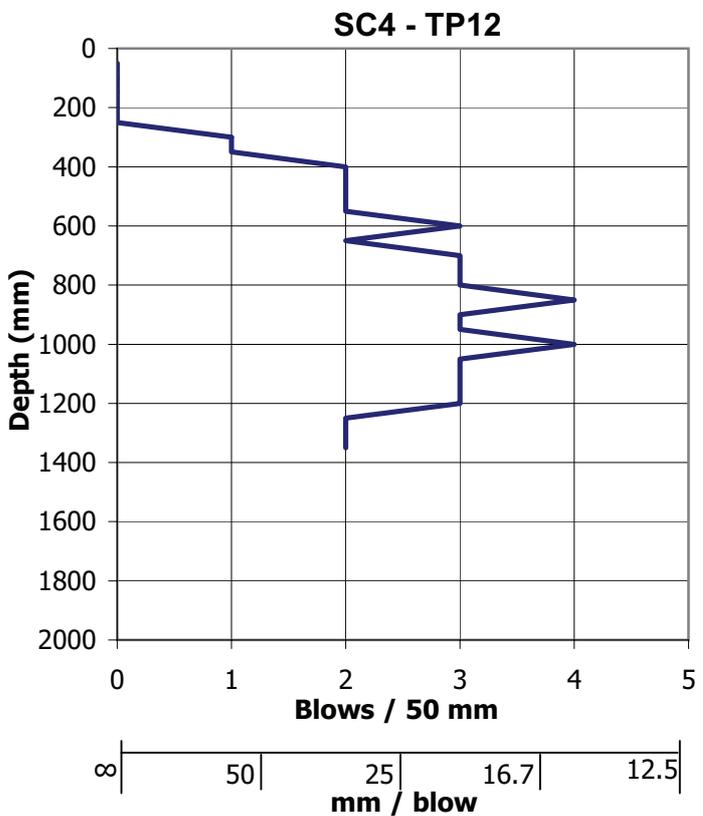
TONKIN & TAYLOR
SCALA PENETROMETER LOG

SC3 - TP9	
Location: RL: 0m	
mm Driven	No. of Blows
50	
100	
150	
200	
250	
300	2
350	2
400	1
450	1
500	2
550	2
600	1
650	2
700	2
750	2
800	2
850	2
900	3
950	3
1000	2
1050	2
1100	3
1150	2
1200	2
1250	2
1300	2
1350	2
1400	
1450	
1500	
1550	
1600	
1650	
1700	
1750	
1800	
1850	
1900	
1950	
2000

SC4 - TP12	
Location: RL: 0m	
mm Driven	No. of Blows
50	
100	
150	
200	
250	
300	1
350	1
400	2
450	2
500	2
550	2
600	3
650	2
700	3
750	3
800	3
850	4
900	3
950	3
1000	4
1050	3
1100	3
1150	3
1200	3
1250	2
1300	2
1350	2
1400	
1450	
1500	
1550	
1600	
1650	
1700	
1750	
1800	
1850	
1900	
1950	
2000

The fill in Test Pit 9 comprises moist, loose, brown silt with minor sand and gravel, and rare roots and cobbles. The fill is uniform, dilatant, non-plastic, and non-stratified. Scala penetrometer testing adjacent to Test Pit 9 indicates that the fill is firm to stiff.
