Wanaka 02

Summary Description

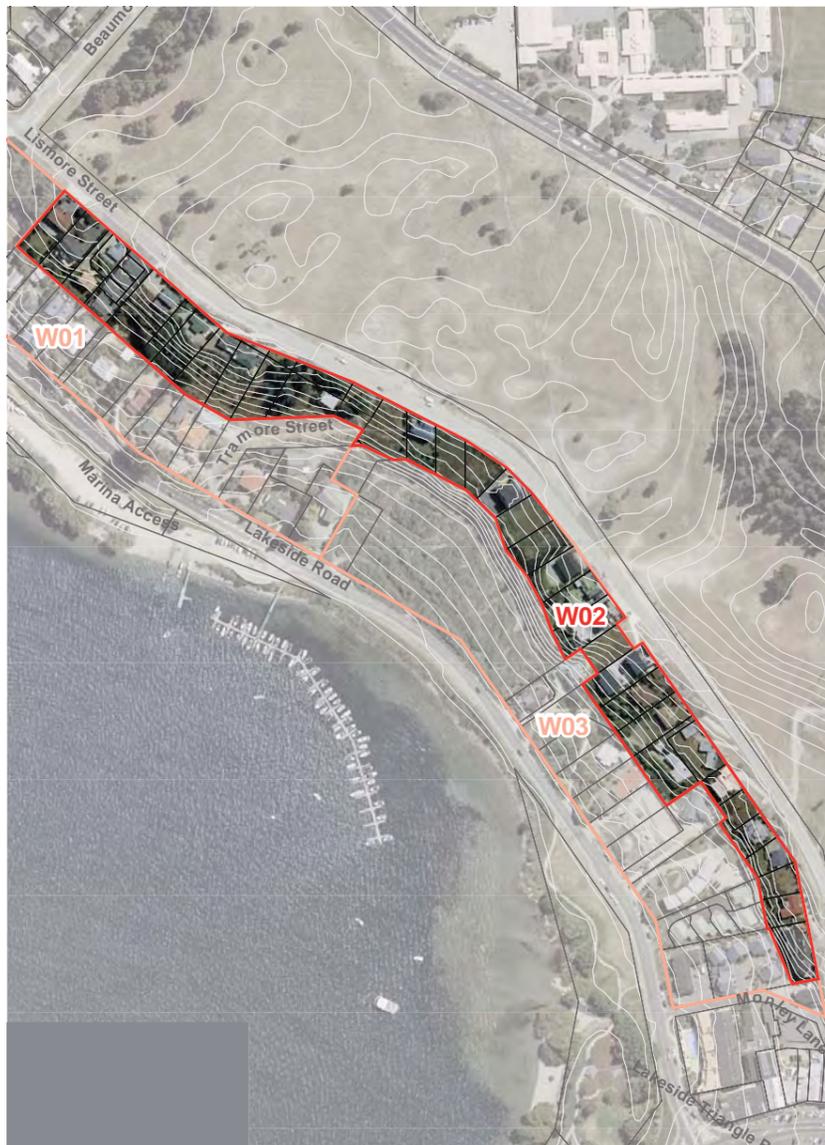
Aerial Photo

This linear character unit lies across the upper portion of the embankment on the southern edge of Lismore Street and Lismore Park. It is separated from the lower slopes adjacent to Lakeside Road by a distinct mid-block gradient change that defines the character boundary between both W01 and W03.

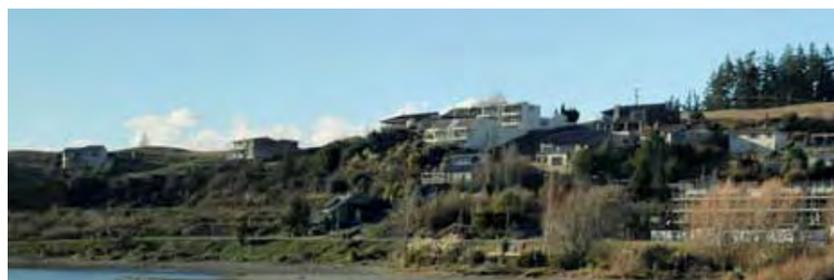
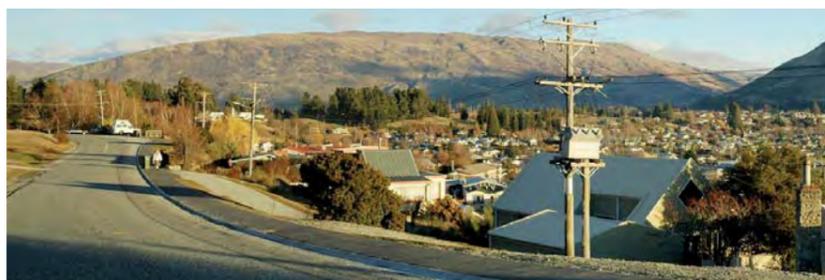
Representative Photos

- Larger two to three storey detached or duplex buildings stepping down the slope on relatively narrow sites.
- A low profile of building height along the upper Lismore Street frontage with tall boundary fences or broad garage doors.
- Small trees and moderately sized vegetation generally located on internal boundary setbacks and on steeper ground below buildings.

- There is a number of vacant lots intermittently located between developments, which affects the overall cohesion of the character unit.
- The low profile of buildings along Lismore Street allows parts of the ridgeline and vegetation on Lismore Park to act as a backdrop to the character unit and views out from the park.
