And The Queenstown Lakes District proposed District Plan –
Rezoning Hearing Topic 12 – Upper Clutha mapping

REBUTTAL STATEMENT OF EVIDENCE OF CHARLES YATES GRANT FOR

Geotechnical Report and Stability Assessment

Albert Town Landslides

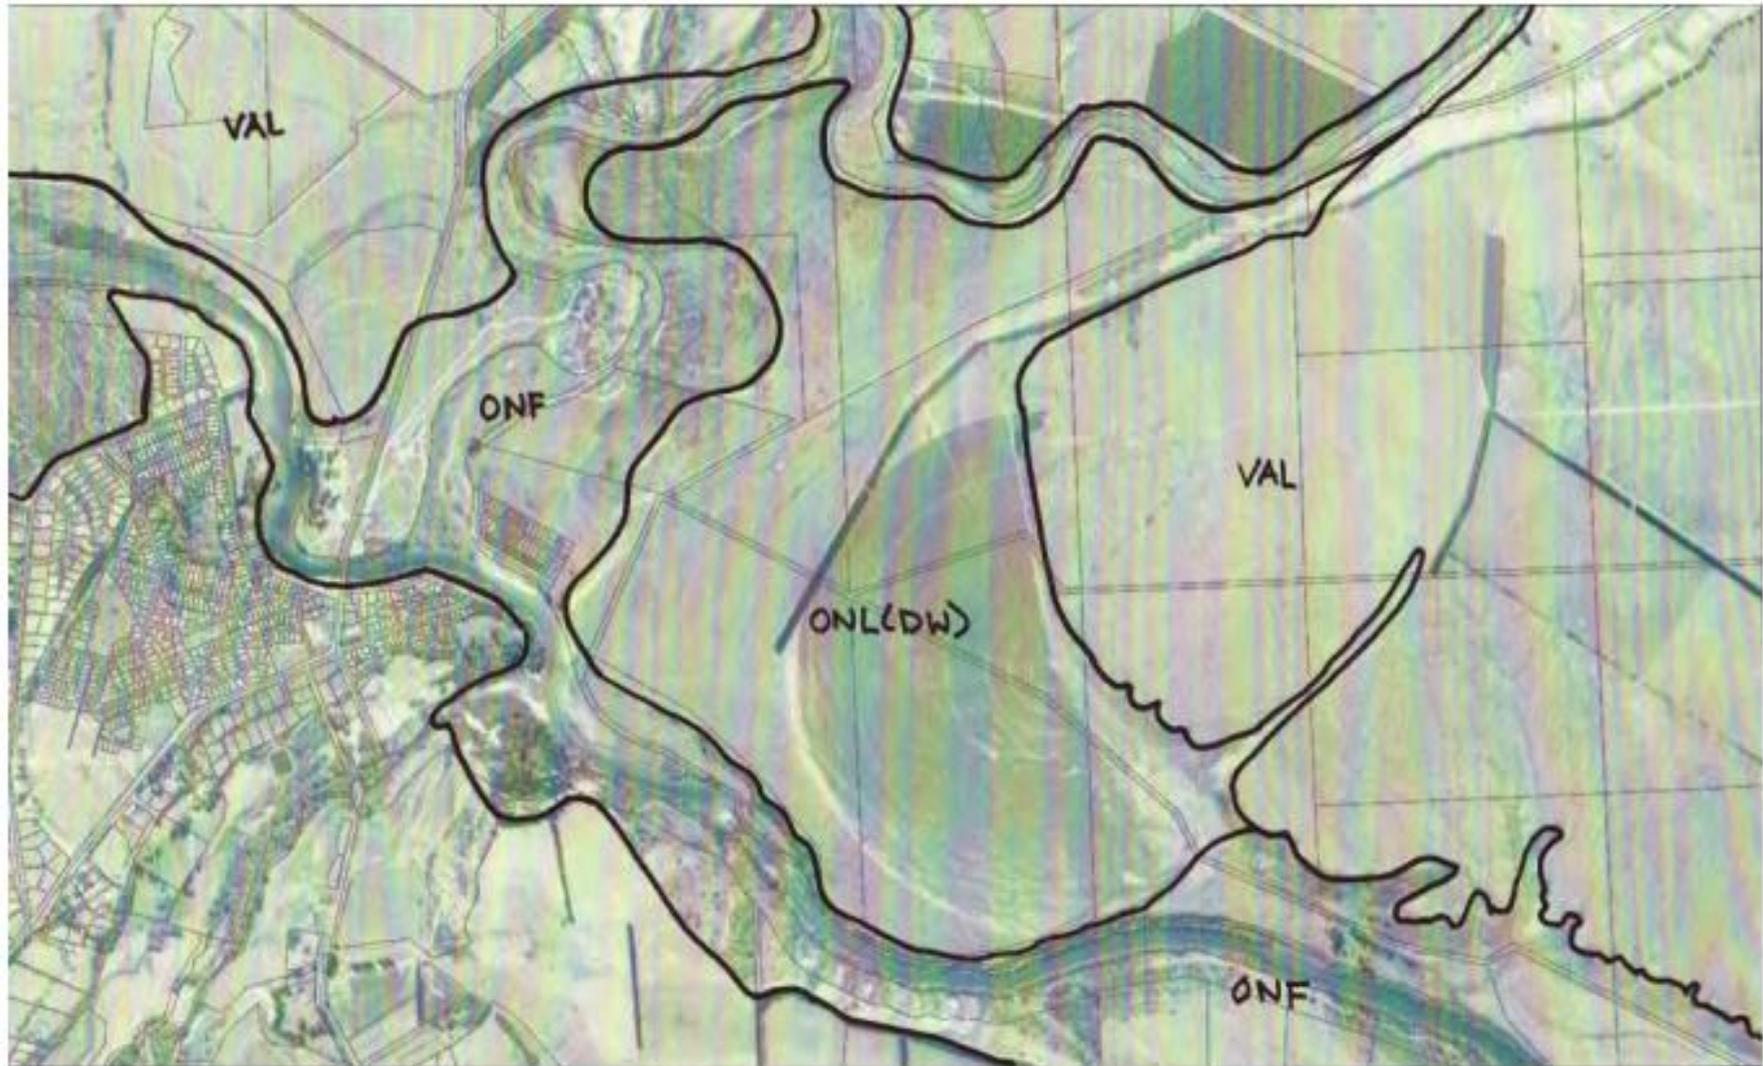
Fig29: Proposed landscape boundaries at the confluence of the Clutha and Hawea Rivers

- 12 Consideration of the ONF boundary as notified in the Proposed District plan ("PDP") indicates that the boundary location has been carefully considered by Council, not just here but all around the Albert Town area. Proper consideration has been given to the setting and that this is an established Residential Area. This is exemplified in Fig 29 of Dr Read's landscape report¹ and associated commentary which identifies the proposed landscape boundaries at the confluence of the Clutha and Hawea Rivers.

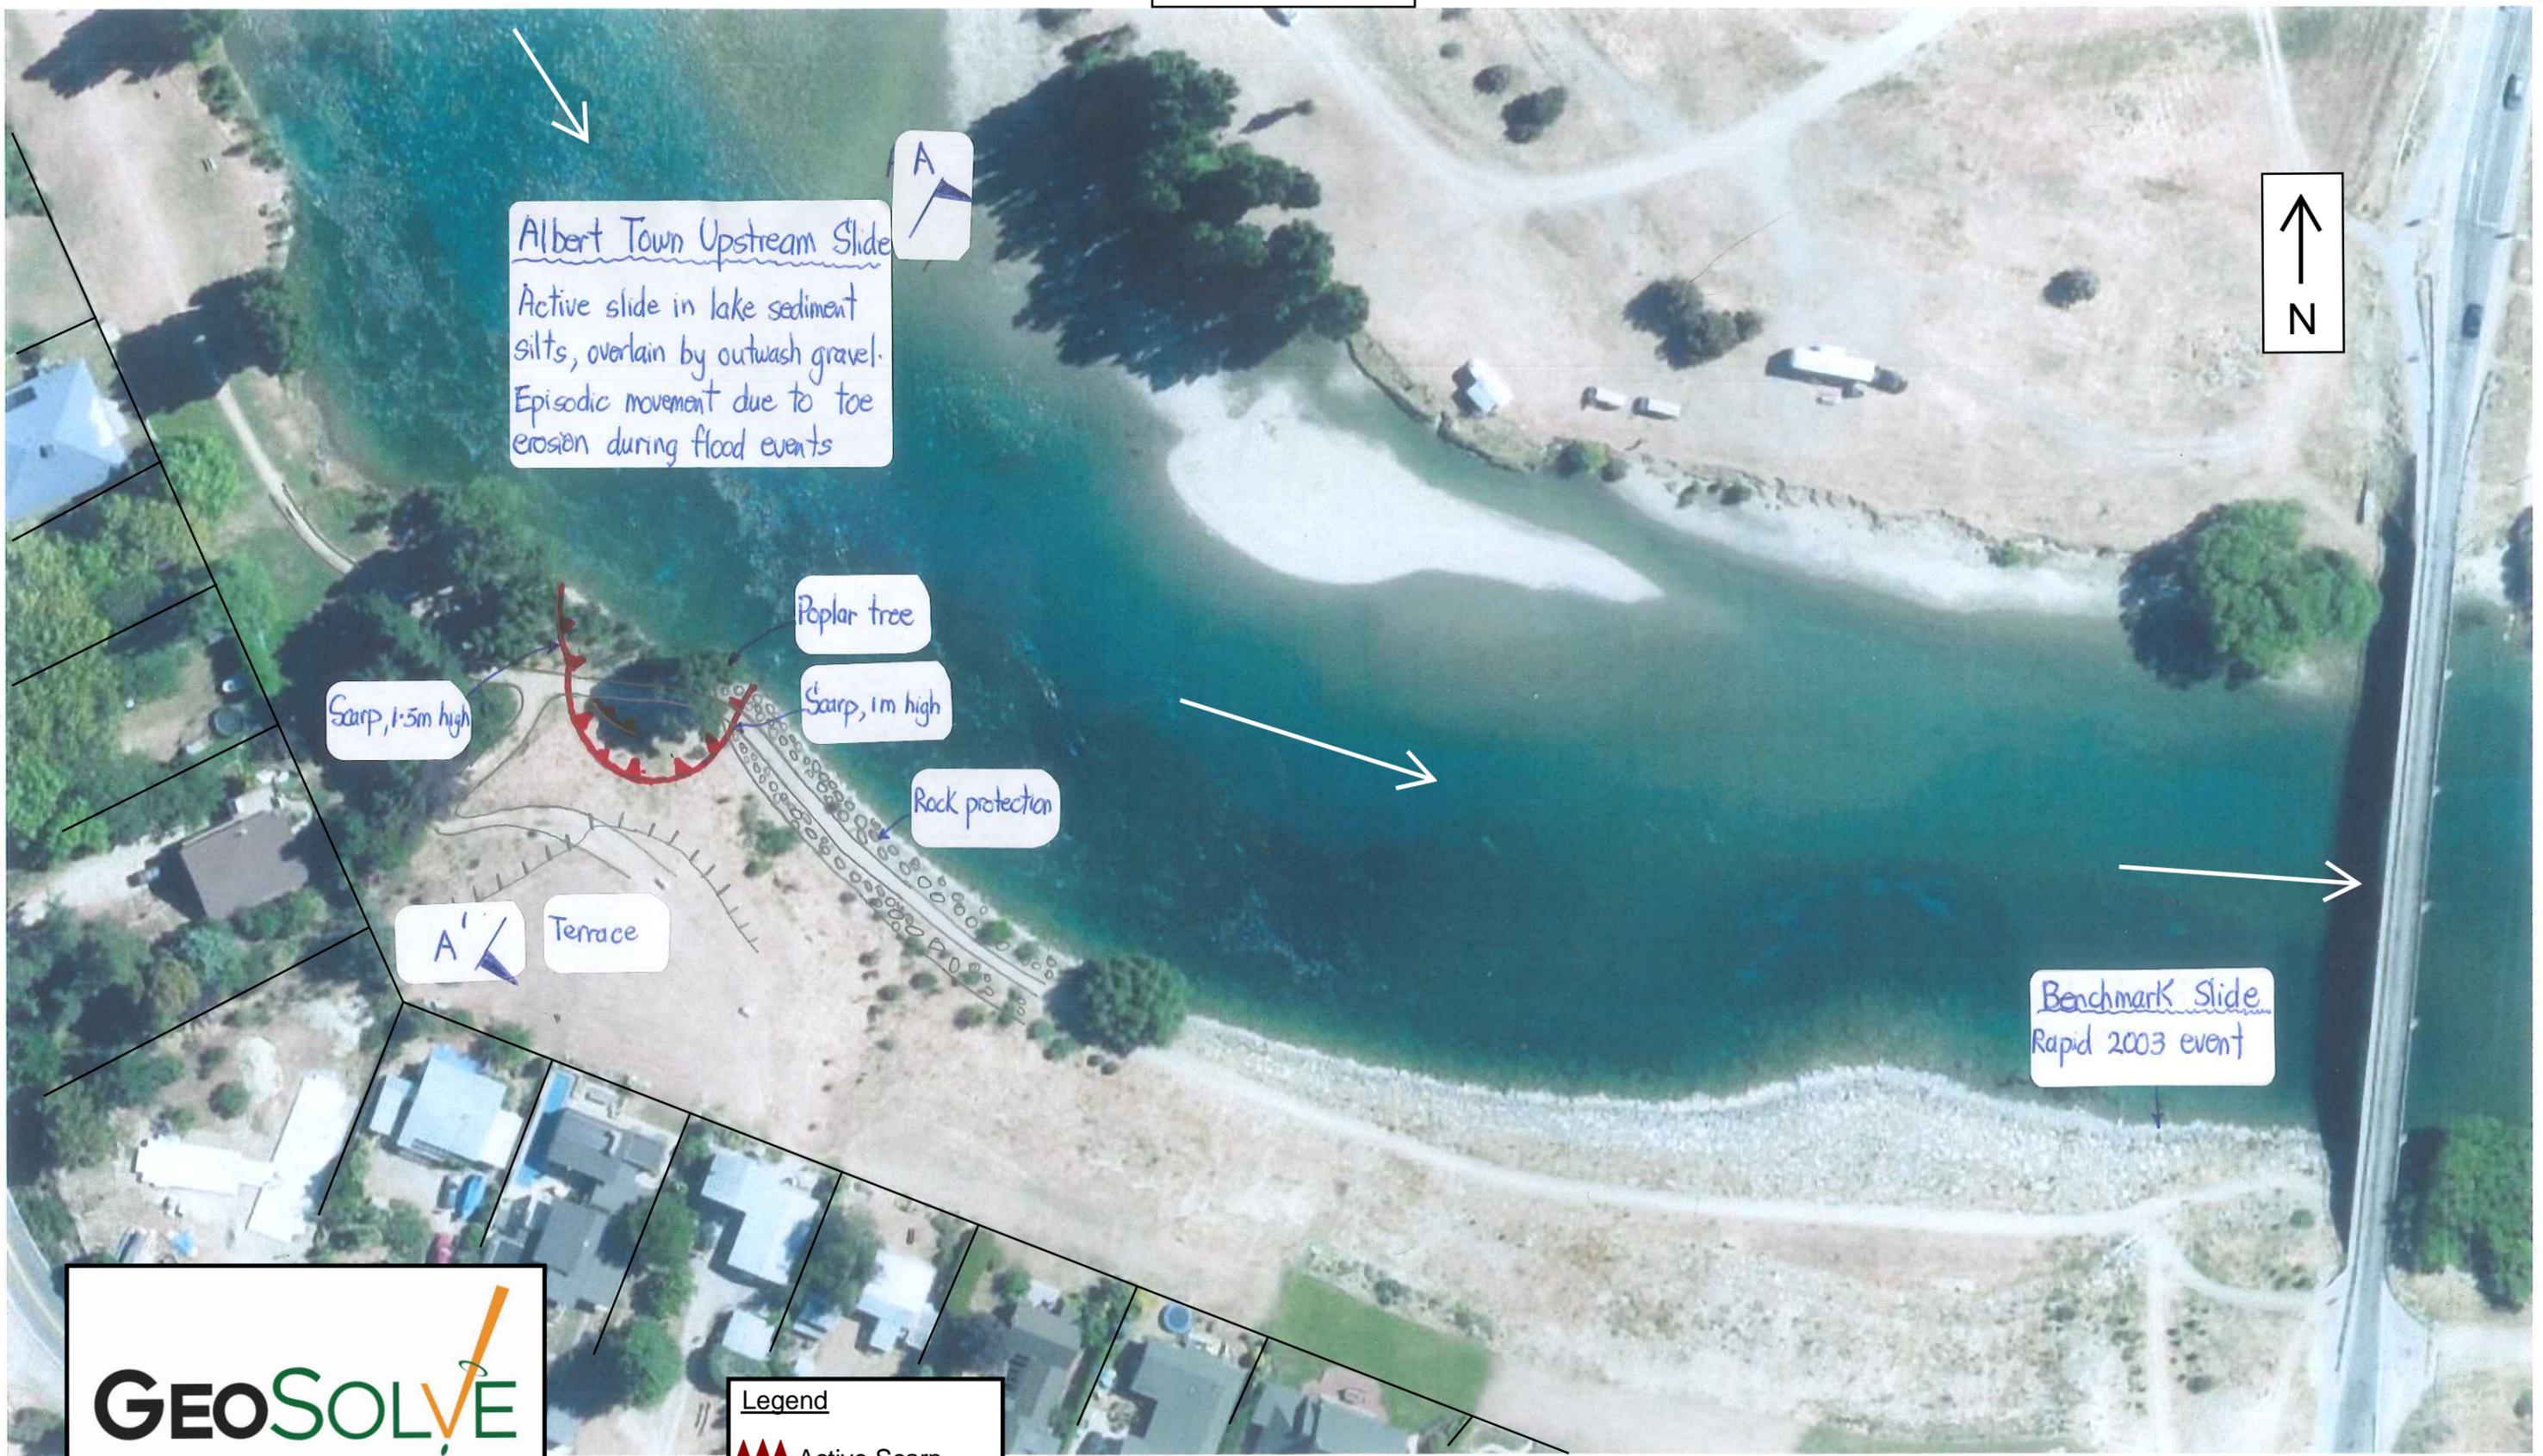
Figure 3
GSH & GCS
Dec 2014

Albert Town Upstream Slide
Active slide in lake sediment silts, overlain by outwash gravel. Episodic movement due to toe erosion during flood events

Scarp, 1.5m high

Scarp, 1m high

Benchmark Slide
Rapid 2003 event

This is a small landslide about 30m wide in a steep terrace face that affects a section of the cycle track along the bank of the Clutha River, about 250m upstream of the Albert Town Bridge (see Appendix A, Fig. 3; and Appendix B, Fig. 5). It has undergone intermittent minor movements in recent years in response to flood events, including the development of a perimeter scarp up to 1.5 m high at the western margin, which produces an abrupt step in the cycle track.

There are several scarps within the landslide which is showing signs of retrogressing back up the slope. The toe is inferred to exit below river level in the deeply eroded thalweg of the river on the outside of the adjacent bend (Appendix B, Fig. 5). The rock revetment along the river bank terminates a few metres onto the landslide, and may be contributing to scouring of the river channel and bank in the landslide toe area immediately upstream owing to possible eddying action (see 3.2.1.1 below).

The landslide is developed largely in laminated lake silts, with outwash gravels lying above an old erosion surface in the upper landslide. A bedding plane-parallel translational sliding mechanism is inferred, due to the presence of weak clayey silt layers along the sub-horizontal bedding. The water table is inferred to generally rise away from the river with moderate gradient.

- The passage of pedestrian and cycle traffic onto the marked instabilities (Appendix A, Figures 3 & 4) and on the upper terrace (Figure 3) and elsewhere within the study area is not considered to apply sufficient loadings to be a significant exacerbating factor.
