Our Reference: P-002185
20 October 2023

Ladies Mile Extension Preliminary Geotechnical Report For Plan Change Application

TE PŪTAHI LADIES MILE ZONE EXTENSION

GEOTECHNICAL INVESTIGATION LOCATION PLAN

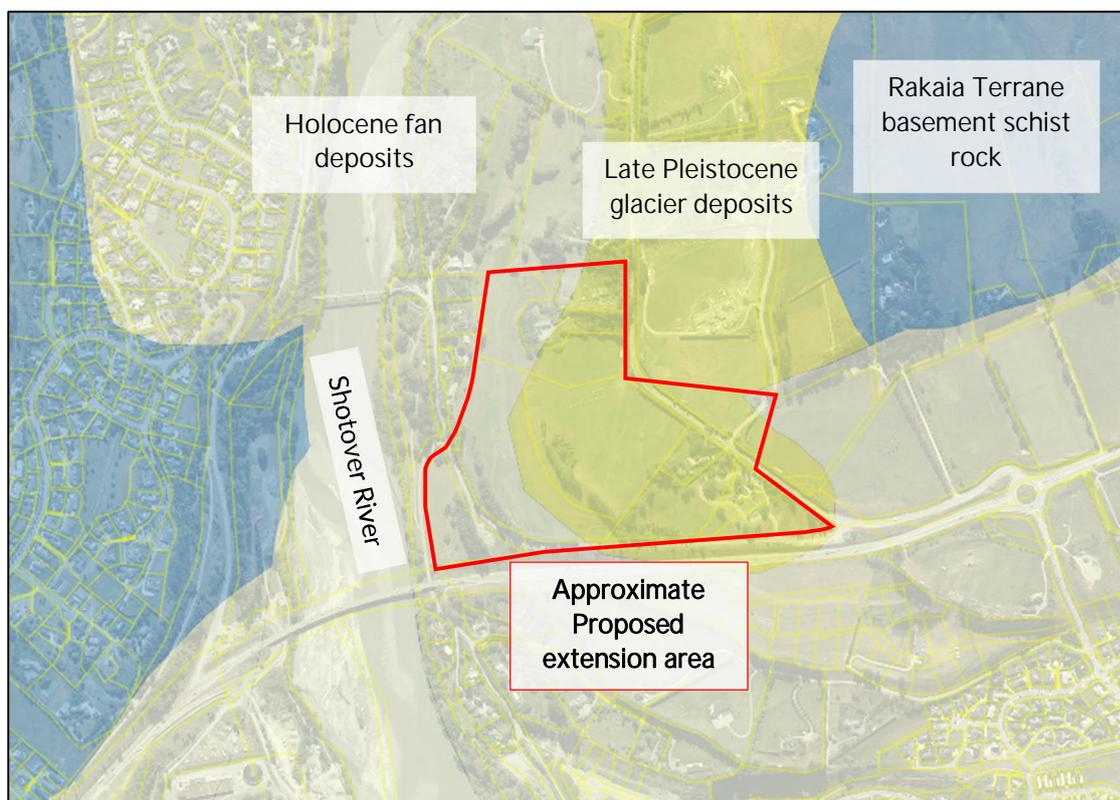
Figure 2: Published Geological Map (Source: GNS Webmaps)

Based on a preliminary review of the published GNS geological maps⁴ (see Figure 2 below) for the area, the upper part of the site is expected to be underlain by Late Pleistocene glacier deposits (yellow) comprising generally unweathered, unsorted to sorted, loose sandy gravel, silt, and sand (till). The lower portion of the site is expected to be underlain by Holocene fan deposits (off white) comprising loose, commonly angular, boulders, gravel, sand, and silt. The site is expected to be underlain by Aspiring Lithologic Association TZIV pelitic schist (blue) (Rakaia Terrane basement schist rock), at depth.

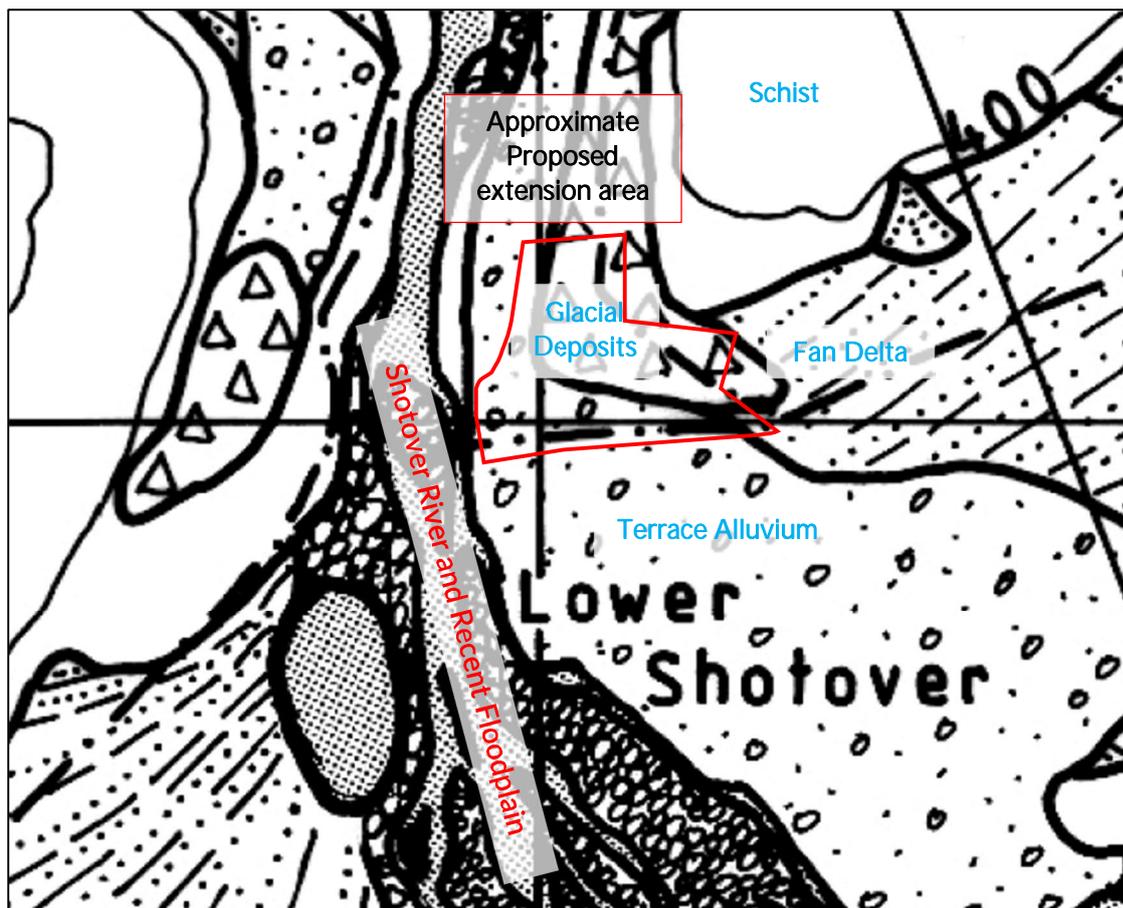
Figure 3: Mapped surficial geology of the Ladies Mile area⁷

In addition to the above, a published map of the surficial geology of the area⁷ has been reviewed. An excerpt from this map is presented as Figure 3 below. The surficial geology mapped is similar to the above GNS published geology, and indicates the site is underlain by Glacial deposits to the north east (Late Pleistocene glacier deposits), and Terrace Alluvium (Holocene fan deposits) across the remainder of the site.
