# E. coli monitoring

## Shotover & Kawarau Rivers

# Water quality sampling locations

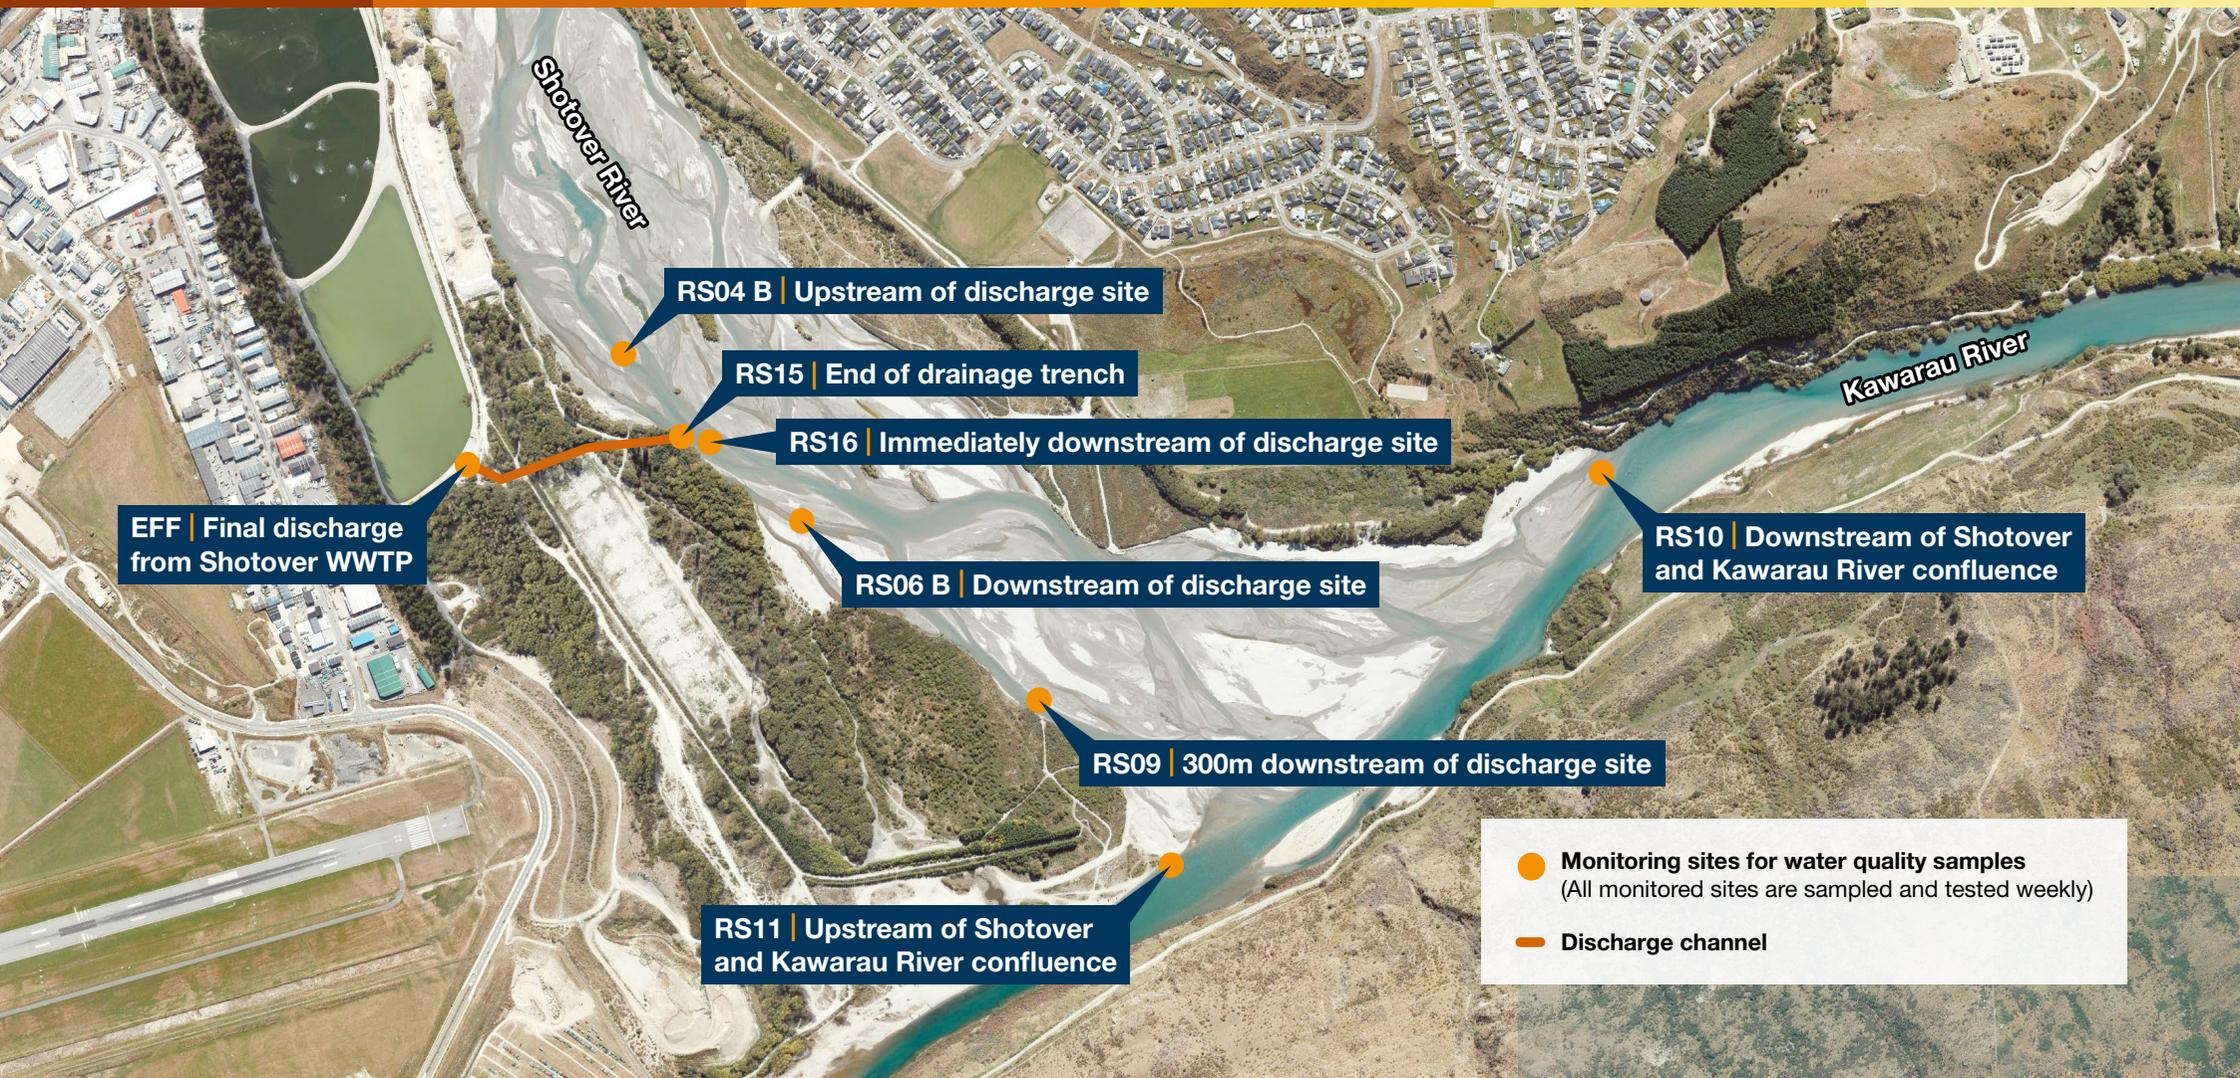
## Shotover & Kawarau Rivers

Shotover WWTP E. coli results									
Parameter		E. coli							
Unit		CFU/100mL							
Location		EFF Final discharge from Shotover WWTP	RS15 End of drainage trench	RS04 B Shotover River upstream of discharge to provide baseline water quality	RS16 Shotover River immediately downstream from discharge channel	RS06 B Shotover River 50m downstream of discharge	RS09 Shotover River 300m downstream of discharge site	RS11 Kawarau River upstream of confluence	RS10 Kawarau River downstream of confluence
Date	3 June 2025	<10	28	1	3	2	3	5	1
	12 June 2025	<10	33	15	190	13	12	9	7
